International Conference on Case Histories in Geotechnical Engineering (1993) - Third International Conference on Case Histories in Geotechnical Engineering

Building Collapse Due to Shallow Trench Excavation

SYNOPSIS: A building collapse is investigated in which a shallow trench, excavated along the length of the building, resulted in the building's collapse. An investigation indicated that the trench had been excavated within 1 ft (0.3 m) of the foundation and that the foundation had been constructed on approximately 7 ft (2.1 m) of soft silty clay with the bottom portion of this soil highly saturated. The bearing capacity of the foundation, prior to excavation, was estimated to have a safety factor as low as 1.5. As a result of the proximity of the trench to the foundation and the soft soils, the trench collapsed soon after excavation. It is believed that the lower portion of the soil flowed into the trench causing a loss of bearing capacity. An understanding of the geologic setting of the foundation soils, coupled with soils information from the USDA's Soil Conservation Service, indicated the hazards of excavating in this soil.

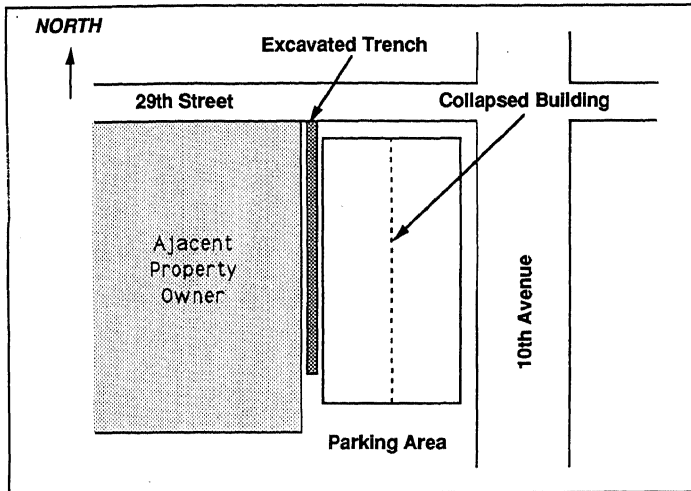
Figure 1 Plan view of the collapse building site.

The collapsed building is located within a mixed residential/commercial section of Tuscaloosa in a southwest section of the city at the intersection of two streets as is shown in Figure 1. The building was used by an electrical contractor as both an office and warehouse at the time of the collapse. The area surrounding the building is characterized as a topographically low area but within a relatively flat section of Tuscaloosa.

A site investigation immediately following the collapse found that the trench for the sewer line had been placed within 1 ft of the foundation. This was done due to the close proximity of the building to an adjacent property line, where only 6 ft (1.8 m) strip of land was available for placement of the sewer line. Based on this finding, the excavation was in violation of applicable building codes, which require "that excavations for any purpose near structures should not extend within 1 ft (0.3 m) of the angle of repose or natural slope of the soil under any

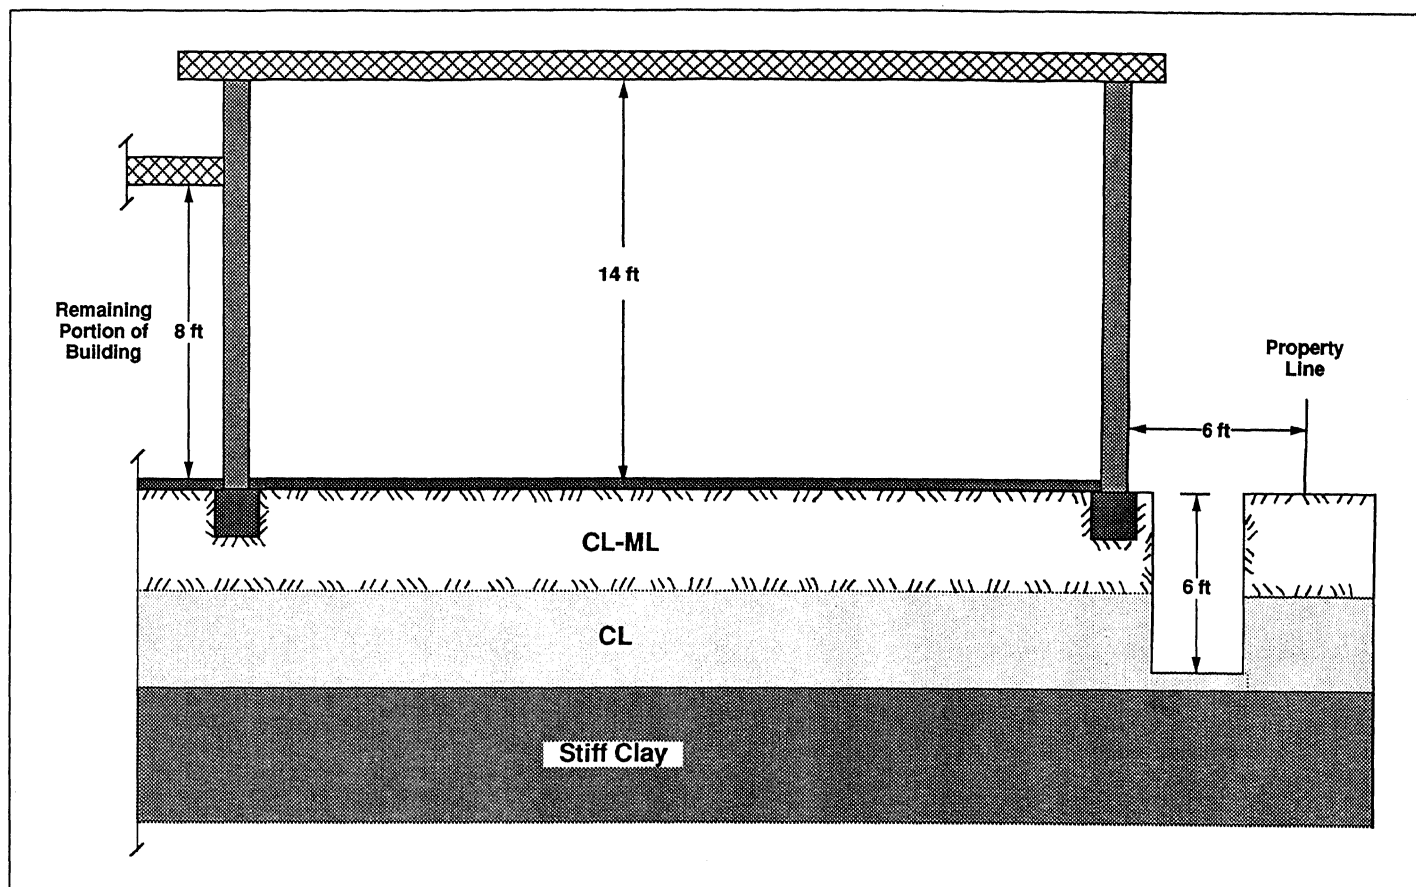
Figure 2 Cross-section of collapse building site.

Classification of the soils was based on the following tests: Atterberg limits, grain size analysis, natural water content, and unit weight tests. Strength measurements were obtained from uniaxial compression tests. The foundation soils were found to be a clayey silt CL-ML in the top 40 in. (1 m) tending to a low plasticity clay CL in a lower zone of 40 to 80 in. (1 to 2 m). The liquid limits of the soils, ranged from 16 to 40% while the plastic indexes were estimated to range from 1.5 to 18%. Void ratios for the undisturbed samples varied between 0.55 and 0.70. The natural water content ranged from 15% near the top of the soil column to 30% near the bottom of the column. The unconfined compressive strength of the soils in the upper 40 in. averaged 1060 psf (50 kPa). At a depth of about 80 in. (2 m), a very stiff clay, difficult to auger through, was encountered in all of the six auger holes completed. Figure 2 illustrates a cross-section of the building, its foundation soils and the estimated location of the excavation relative to the building.

Based on the above analysis and information gathered at the site, the most probable collapse mechanism was that once the trench was excavated, the bottom soil, which was highly saturated and possibly near its liquid limit, flowed into the trench, thus undermining the upper bearing soils and resulting in the collapse of the building. This may also account for the time lag that occurred between the completion of the trench and the collapse, which was about 1 hour.

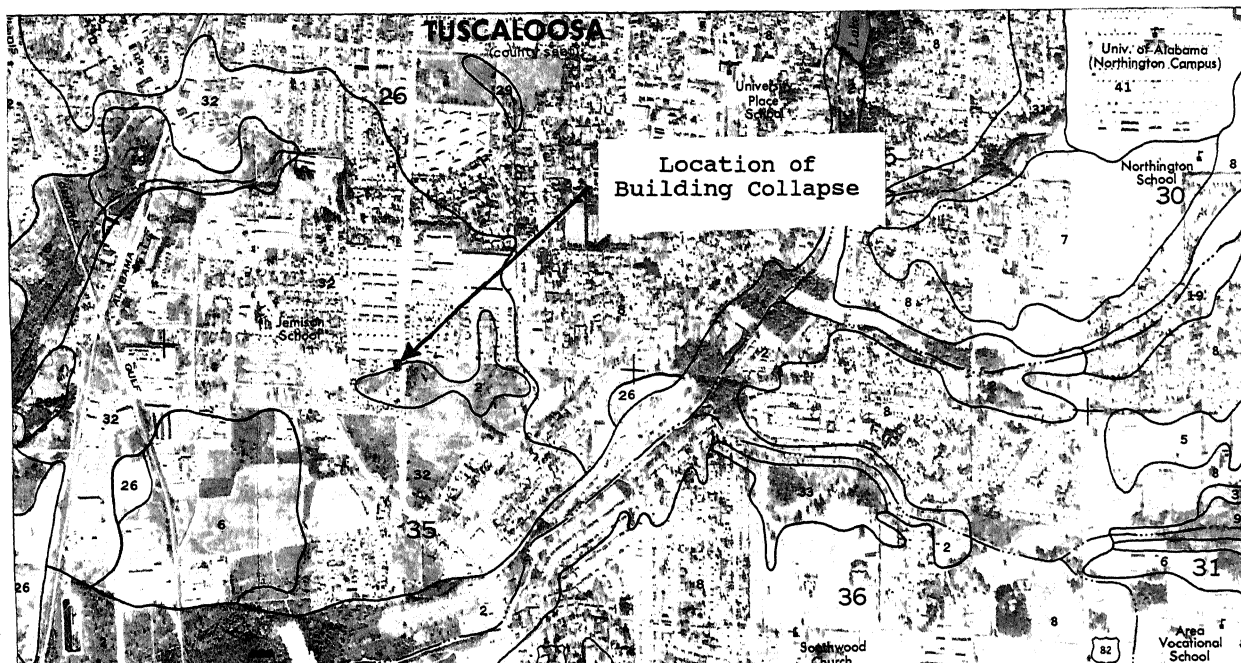
Figure 3 Soil Conservation Service soil survey.

Since the foundations are relatively shallow and the strip footings located at a depth of 18 in. (457 mm), the USDA Soil Conservation Service soil survey of Tuscaloosa County (1981) was reviewed for additional information concerning the area's soils. This survey had been issued in August of 1981, with the major field work being conducted from 1971 to 1979. Figure 3 below shows the general soil map for the area of the building collapse. As can be seen from Figure 3, the building is located at the contact of a soil type

identified as a number 2 and described in the soil survey as a Adaton silt loam. According to the soil survey, the Adaton series consists of deep, poorly drained, slowly permeable soils that formed in silty fluvial sediments. In addition, the soil survey provides information for planning land uses related to urban development such as building site development and engineering index properties. For building development, the Adaton soils were classified as being "severe" for building shallow excavations and dwellings without basements. This was primarily due to the soil's wetness and low strength. Figure 4 lists the engineering index properties of the Adaton soil series. It can be seen from Figure 4 that the basic engineering property tested confirmed the field test previously reported.

channels. This can be seen in Figure 3 where Adaton silt is located to the southeast of the building collapse area.

The pod-like nature of this soil suggests that it was a low area where sediments collected over time. This low area may also have been part of an extended drainage system for receding flood waters but over time filled with sediment. As is typical of areas that accumulate sediment, the sediment tends to be silt, which is a highly erodible soil, along with some clays. The results of the Atterberg limits test indicate that the top portion of the foundation soils are a low plasticity silt that graded into a low plasticity clay. This would suggest that the foundation soils formed over a long period of time from surface erosion which would tend to collect more silty than clayey soils, as opposed to resulting directly from the receding flood waters. Since this area is topographically a low area, it would also tend to collect water. This was confirmed by field observations in which the auger holes encountered highly saturated soils in the lower portion of the auger holes. It appears that a stiff clay, located at a depth of about 7 ft (2 m), trapped water above it.
